CALIFORNIA DIVISION OF MINES AND GEOLOGY
Supplement ^{#2} to Fault Evaluation Report FER-13

March 23, 1978

1. Name of fault: Ventura fault.

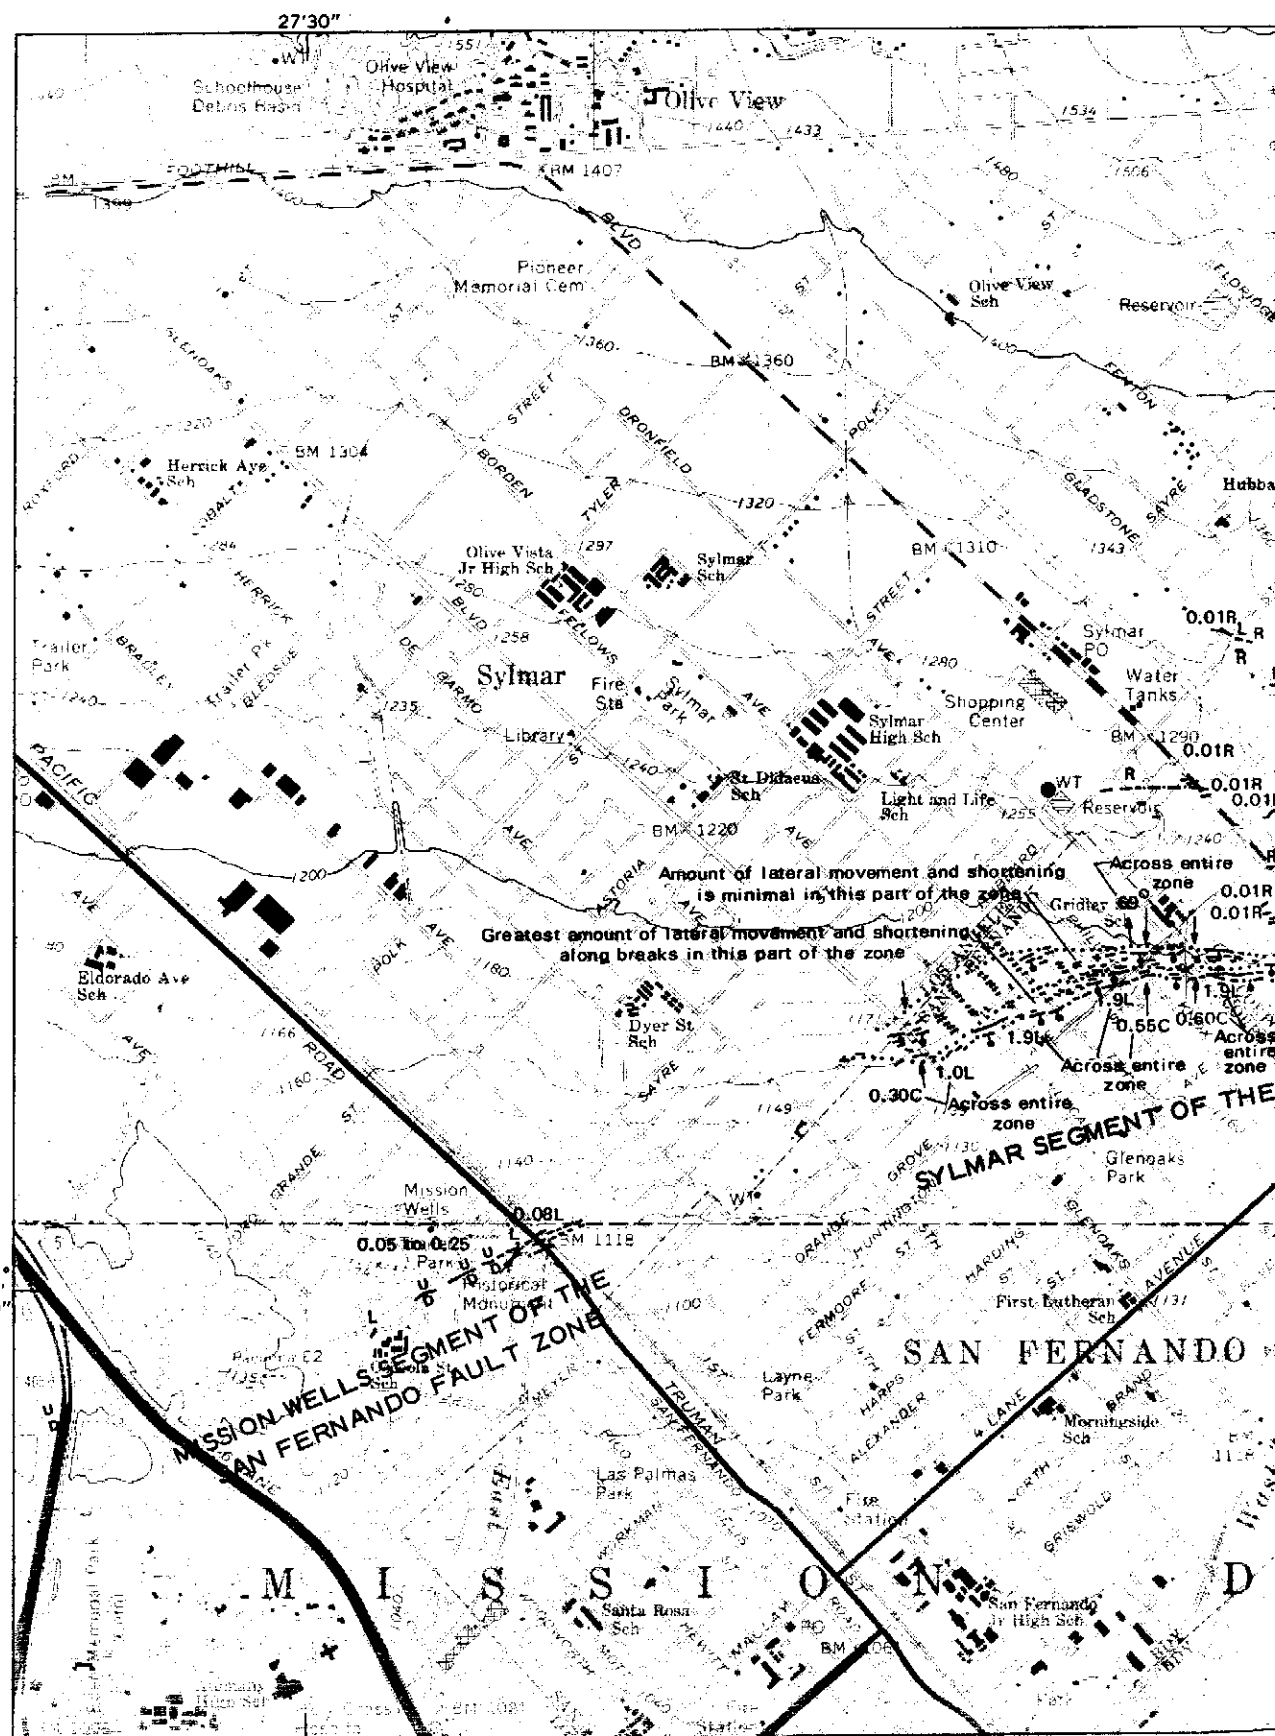
FIGURE 2.—Map showing tectonic ruptures formed during the San Fernando earthquake of February 9, 1971. Figure 2 continues on following pages.

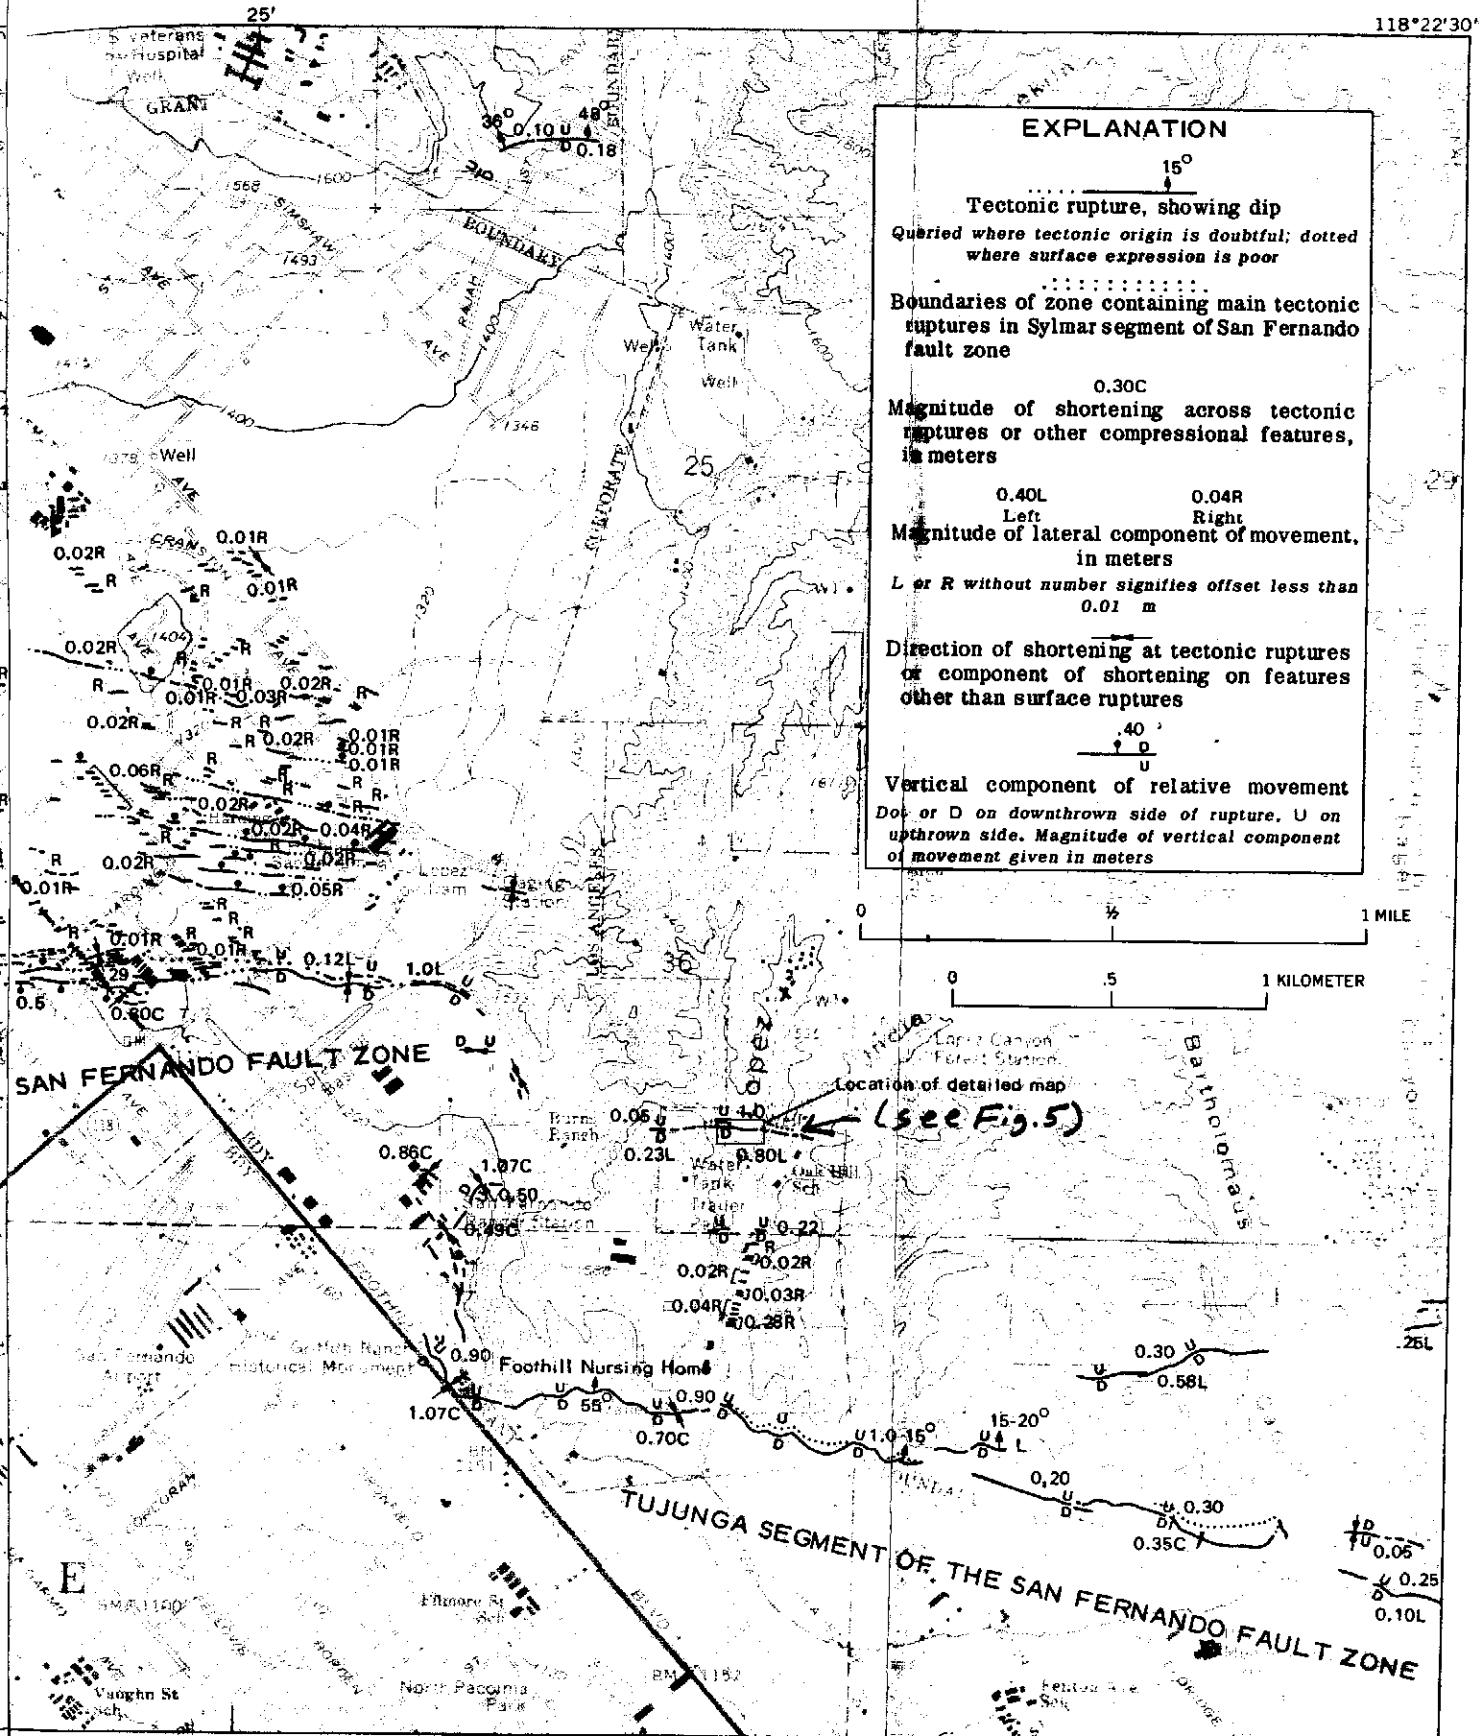
FIGURE 2.—Continued.
